**District of Columbia
Historic Preservation Guidelines**

**WALLS AND
FOUNDATIONS
OF HISTORIC
BUILDINGS**

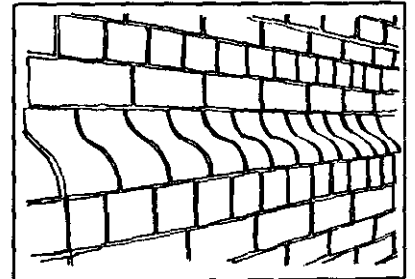
A belt course is often used at the junction between the wall and above ground foundation.

Above ground foundation walls are often visually distinguished from the main wall by a change of plane. For example, brick and stone foundation walls are often visually separated from the wall above by a belt course of molded brick or shaped stone. In other cases, foundation walls are visually distinguished from walls by a change of material. The material used for an exposed foundation wall, how it is finished and how it connects to the wall above, are all distinguishing characteristics.

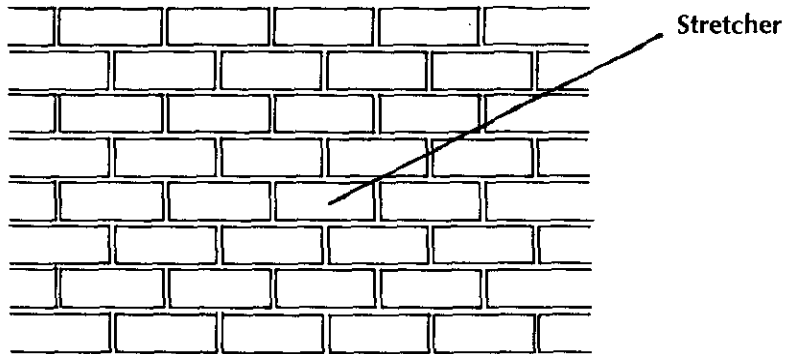
Running bond consisting of all stretchers.

Walls and foundations are laid in different ways. Pressed brick is laid in a running bond. Other types of brick are usually laid in common and Flemish bond. In addition to the coursing, the width, color and profile of mortar joints contribute significantly to the appearance of the wall. Mortar joints vary from 1/8" to 1/2" in width, although other widths exist. Common mortar joint profiles include struck, weather, and flush. Other less common profiles include raked, vee and concave. Mortar is naturally a grey-white color, although some mortar used in historic brick walls and foundations is red or some other color due to the addition of coloring agents.

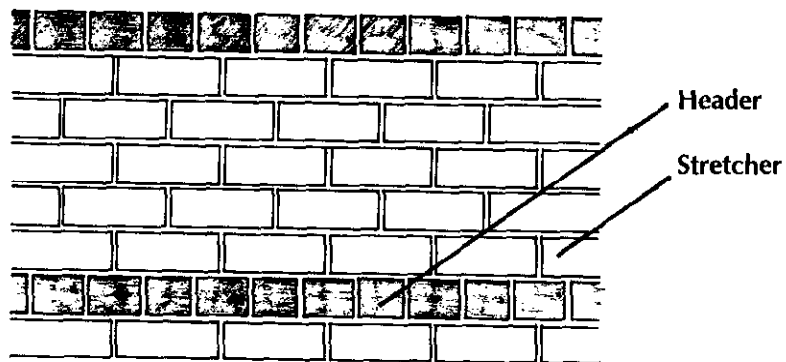
Common bond consisting of five rows of stretchers and one row of headers.

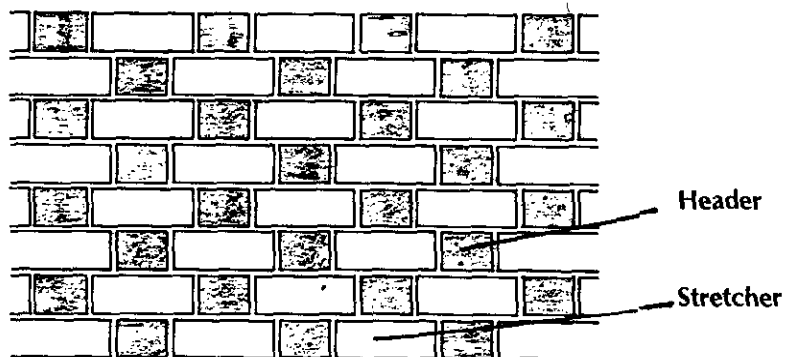
Flemish bond consisting of alternating rows of stretchers and headers

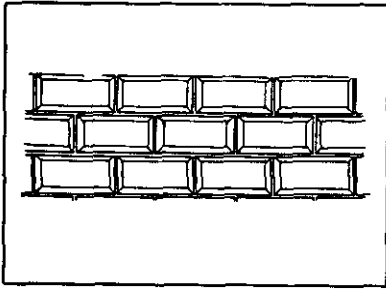
Cast stone was a popular wall material from the 1900s to 1940s.

Cast stone was popular from the 1900s to 1940s as an inexpensive substitute for stone. Made from concrete, the exposed face is finished to resemble rock face ashlar or other stone finishes.

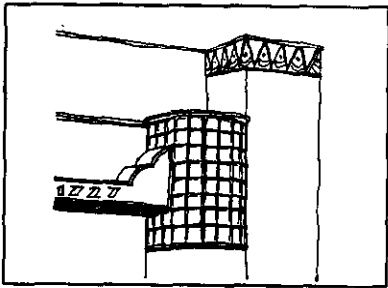
Glass block and stucco are often used for Art Deco buildings.

Appearing after 1930, glass block was a popular wall material for Art Deco buildings, although examples can be found in other building styles. Used as either a wall or window material, glass block is found in a variety of textures and appearance.

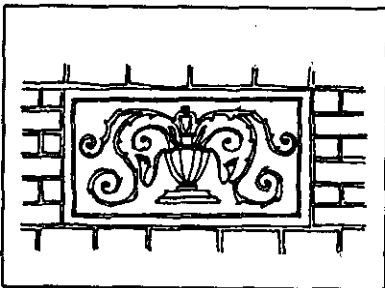
Terra cotta is often used for details and ornamentation.

Terra cotta is a glazed masonry product popular for facades of commercial buildings built between the 1870s and 1930s. It was also extensively used for details and ornamentation on apartment, institutional, government and other types of buildings. Terra cotta may be natural brown-red in color (hence, its name) or glazed in a wide range of colors.

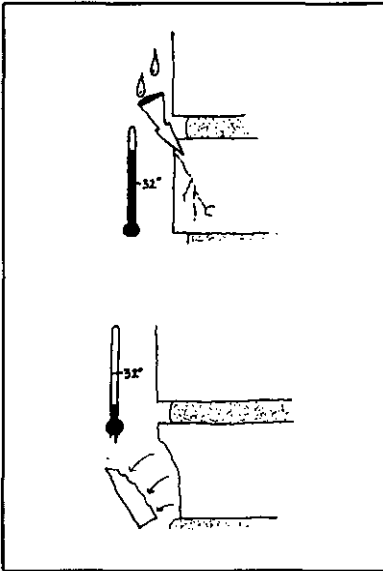
Spalling occurs when water freezes behind brick and stone surfaces.

Brick and stone are among the most maintenance free materials used for historic buildings. However, they are subject to deterioration. One of the most common problems, called spalling, happens when water penetrates the surface through pores or cracks. In cold weather the water will freeze and expand causing the surface of stone or brick to spall or break-away. Over time, the face of stone or brick can become deeply eroded.

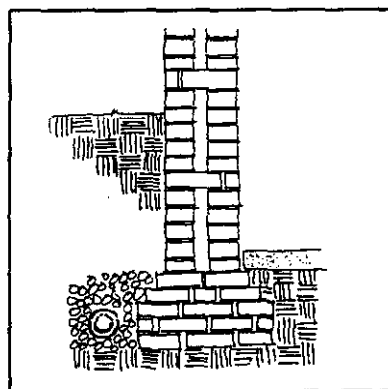
A French drain is used to channel ground water away from foundations.

In the nineteenth century, the below-grade outer surface of brick and stone foundation walls were sealed with a cement-based coating. Foundations constructed in the twentieth century were usually sealed with a tar-based material. Both act as a water-proof membrane, keeping the crawl space or basement dry and preventing rising damp. In addition, most historic free-standing buildings had French drains made of perforated clay tile. Installed at the base of the foundation wall, they carry ground water away from the building.
